# TOYOTA

## Service Bulletin

Ref. No. : EG-5010

### **Subject : Handling of DTC "P0420/P0430" Case by Models**

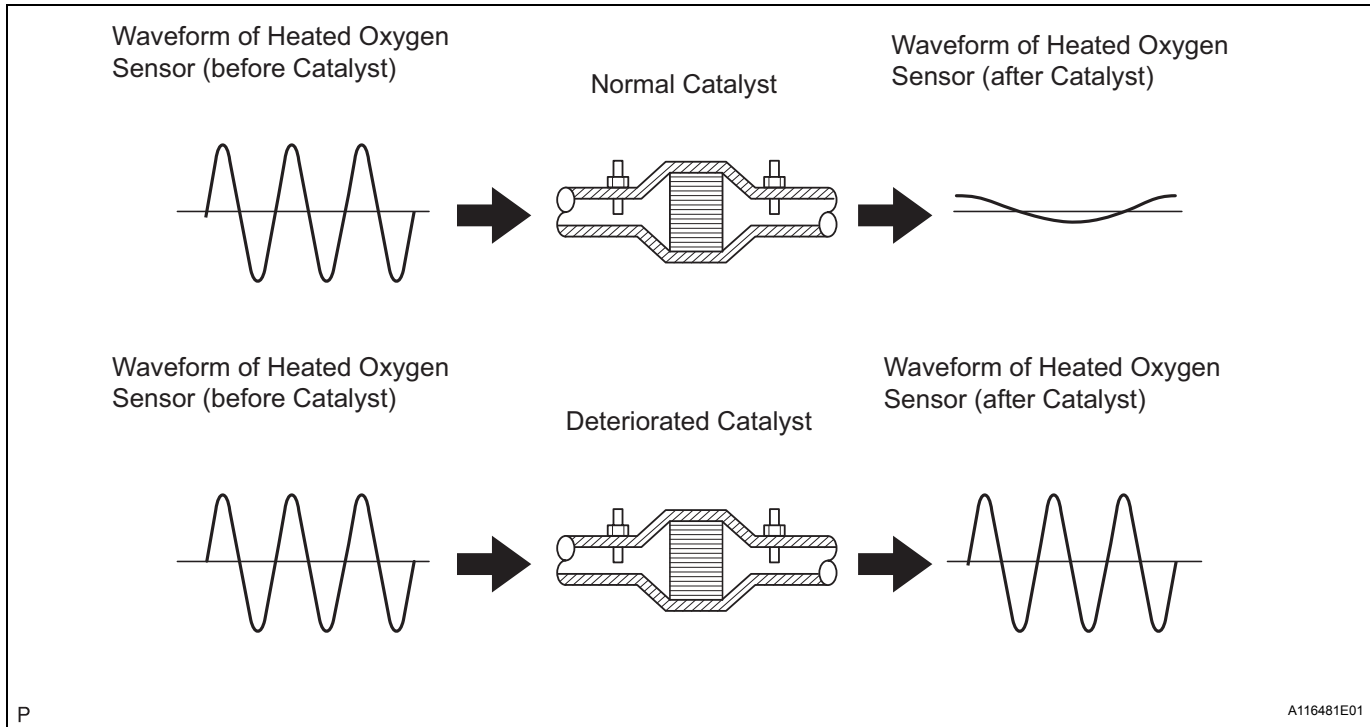
(a) Refer to the oxygen sensor output signal waveforms below.

- In case of normal operating catalyst, the output signal of the rear heated oxygen sensor shows very slow activity.
- If the catalyst has deteriorated, the output signal of the rear heated oxygen sensors becomes very similar to that of front heated oxygen sensor.
- If, based on the sensor signals, you judge catalyst is not working properly, replace catalyst and not the O<sub>2</sub> sensors.

## 2. Inspect Catalytic Converter efficiency by measuring O<sub>2</sub> sensor signals, and replace converter if necessary
