Section : Wind noise/
Squeak/ Rattle
Ref. No. : WS-3002
Date : Dec., 2003
Page : 1 of 6

Model Name : RAV4

Subject : Back Door Rattle

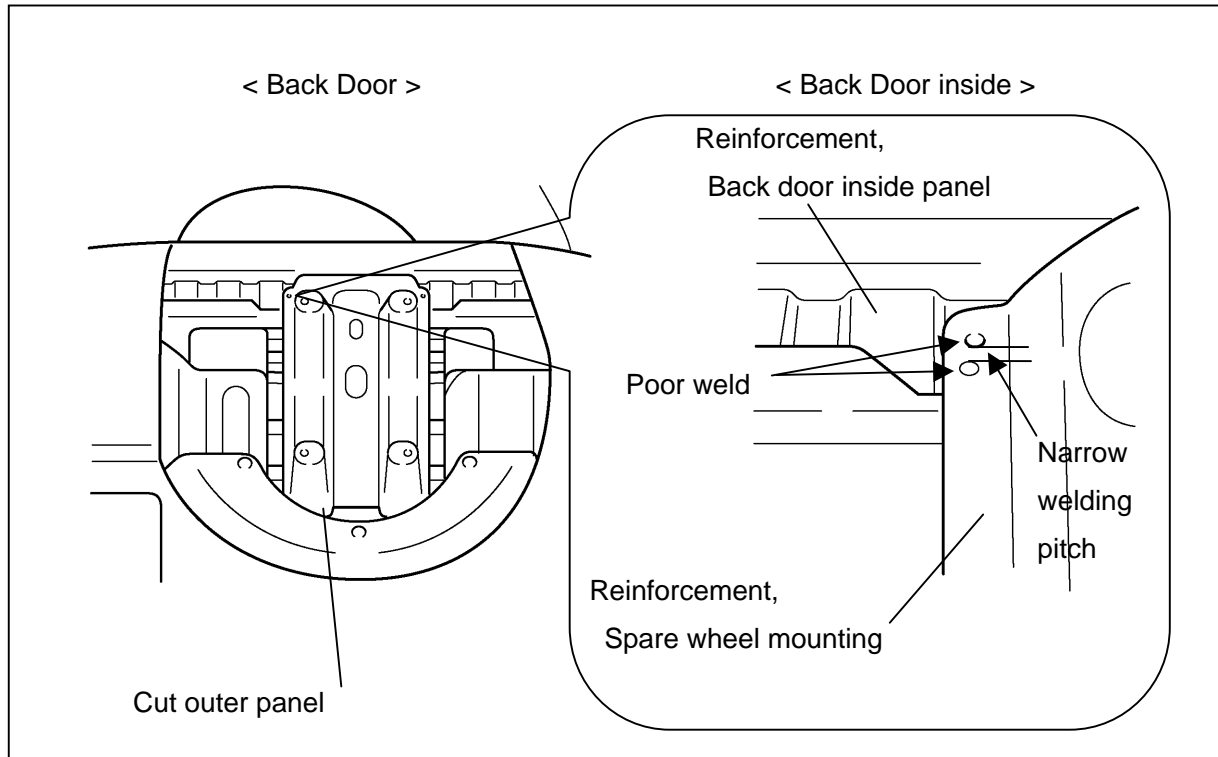
This rattle generated from the poor welding points that resulted from a shunt current due to the narrow welding pitch.

Re-welding of the affected welding points LH and/or RH.
