**Technical Service BULLETIN**

Title: **NOISE FROM TOP OF DASH**  
Models: '01 - '02 RAV4

NVAH  
REVISED  
NV013-01

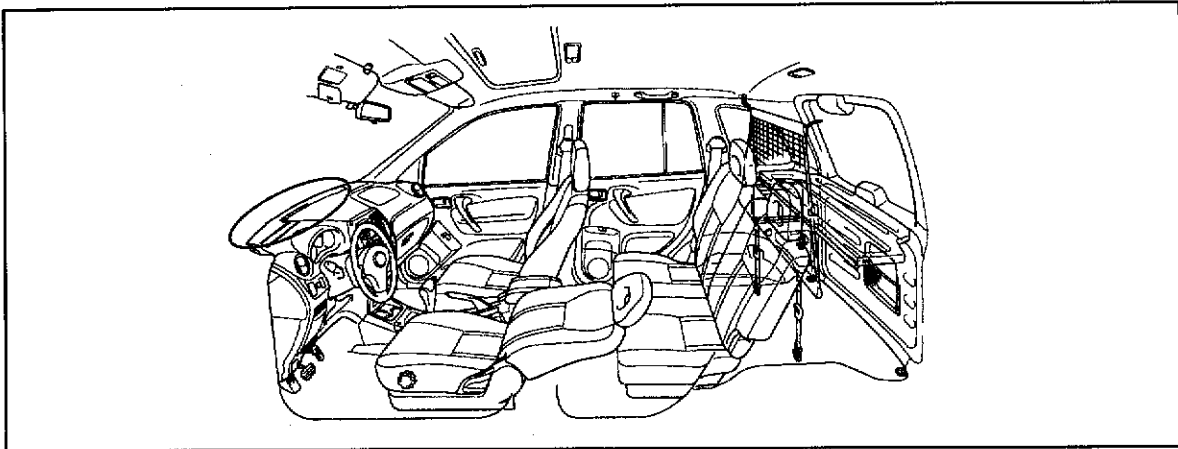
**Introduction** The following procedure has been developed to reduce noise from the defroster duct contacting the underside of the instrument panel.
