**Technical Service  
BULLETIN**

**COWL PANEL WATER LEAK**

'06 – '07 RAV4

**REVISÉD**  
**B0021-06**  
**BODY**

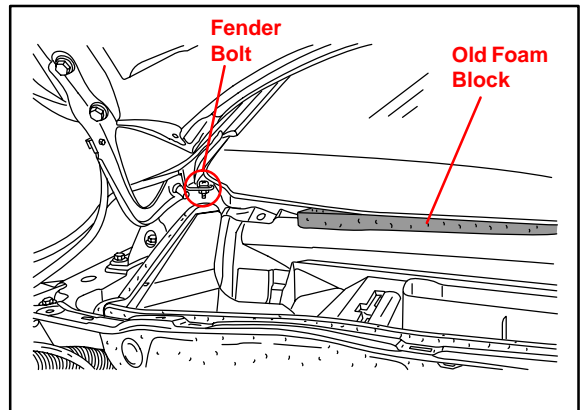
8. Remove any additional factory installed foam, if present, from the areas described below.  
A. Inspect the base of the windshield for foam that is positioned 137 mm (5.5 in.) away from the upper fender bolt on the passenger's side (refer to the illustration).

**Old Foam Dimensions:**

**Length: 275 mm (10.8 in.)**

**Width: 12 mm (0.5 in.)**

**Thickness: 12 mm (0.5 in.)**

- B. Locate and remove the OLD foam on the underside of the cowl top ventilator louver.

**Length: 325 mm (12.8 in.)**

**Thickness: 25 mm (1.0 in.)**

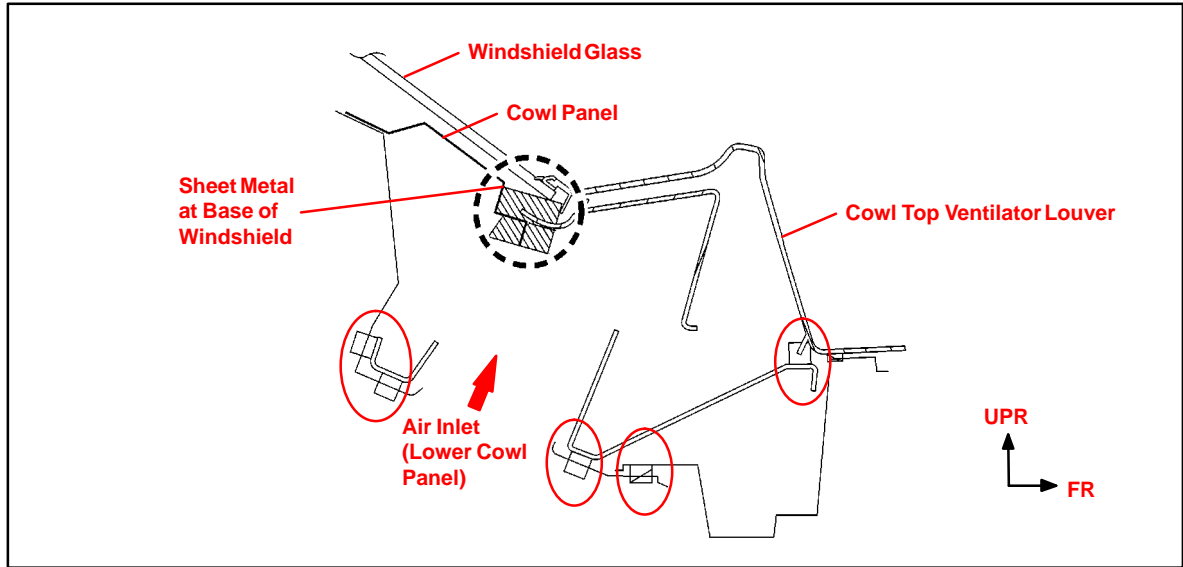
**NOTE:**  
Confirm that the lower cowl panel is properly installed and the seals (circled in red above) are NOT damaged or deformed.

- B. Make sure the seal plate (foam block) is fully pressed against the sheet metal under the base of the windshield.
