# TOYOTA Technical Service BULLETIN

## Title: HEADLAMP SERVICEABILITY

Models:  
'01 RAV4

BODY  
B0009-01

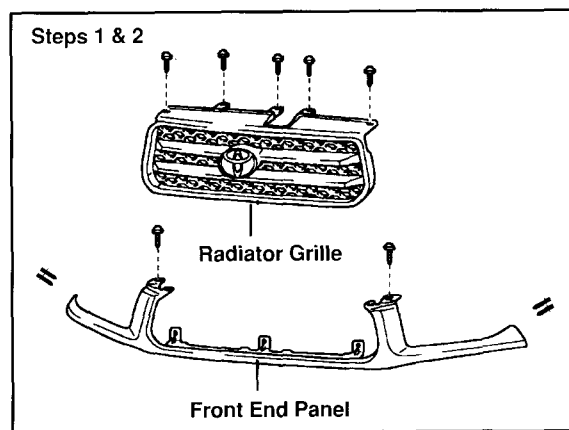
1. Remove the radiator grille.
2. Remove the front end panel.

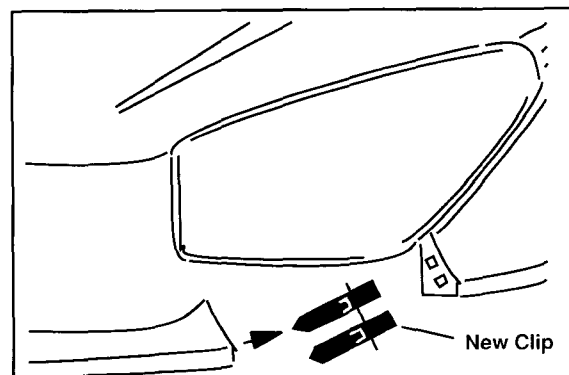
#### NOTE:

There is a new style clip used to hold the outer edges of the front end panel to the fenders. Use a nylon pry tool or taped screwdriver to hold the two panels apart while you LIGHTLY depress the two tabs on the plastic retainer.

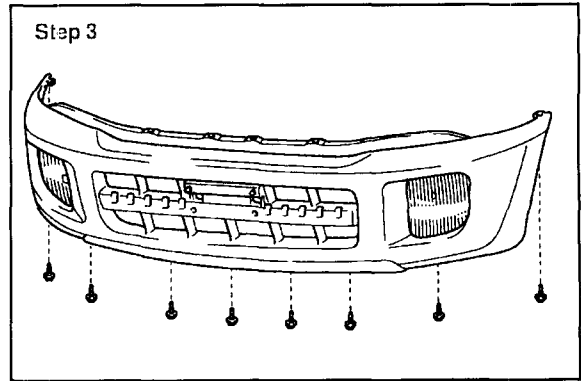
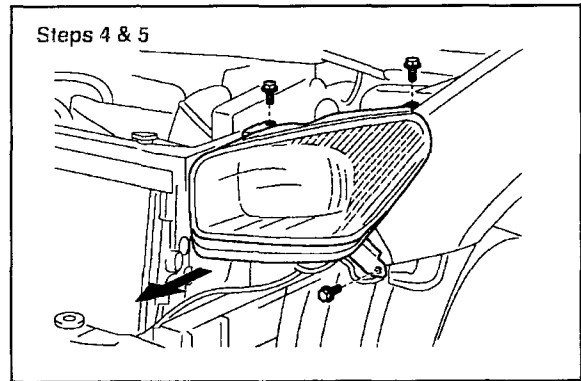
4. Remove the 3 screws retaining the headlight assembly.

5. Disconnect the electrical connectors and remove the headlight assembly from the vehicle.

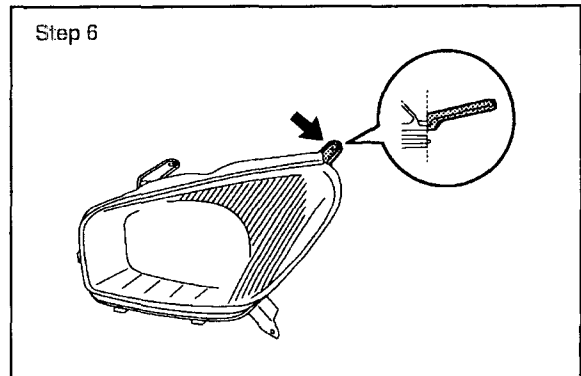
6. Cut the damaged tab from the headlight assembly at the base of the tab as shown.

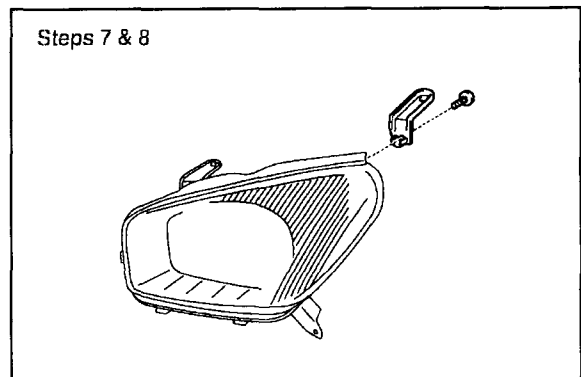
7. Attach the replacement tab/bracket to the back of the headlight assembly using the provided screw as shown.
