Section : Pre-Delivery
 Ref. No. : PD-0008
 Date : April 2000
 Page : 1 of 1

Model Name : RAV4

Model Code : ACA20, ACA21, ZCA25, ZCA26

Subject : CUT FUSE INSTALLATION DURING PDS

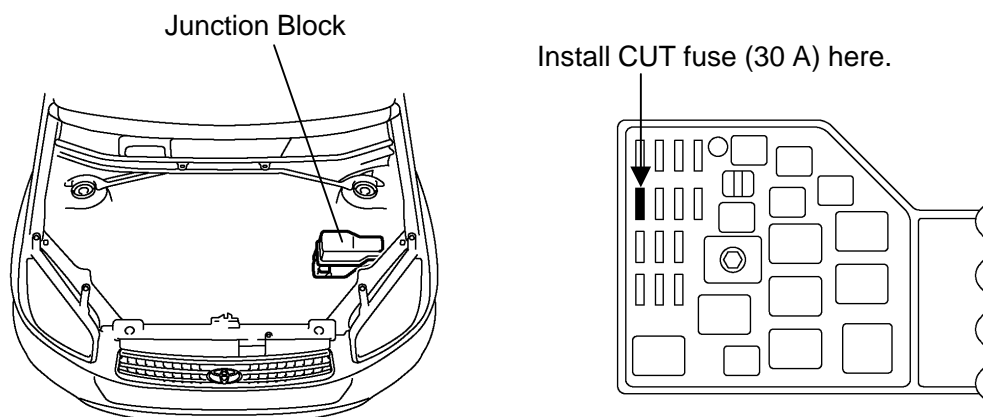
The removed CUT fuse (30 A) is stored on the back of the Junction Block cover in the engine compartment.

The CUT fuse must be reinstalled during PDS (Pre-Delivery Service) in dealership as shown below.

- Removing the CUT fuse cuts off power sources relating to the DOME fuse and RADIO fuse.
- If the vehicle is stored in dealership for a long time after installation of the CUT fuse in PDS, please disconnect the negative battery terminal to prevent parasitic current draw from flattening the battery.
