**Technical Service
BULLETIN**

PARKING BRAKE CLICK NOISE

'06 RAV4

**BRAKES
BR003-06**

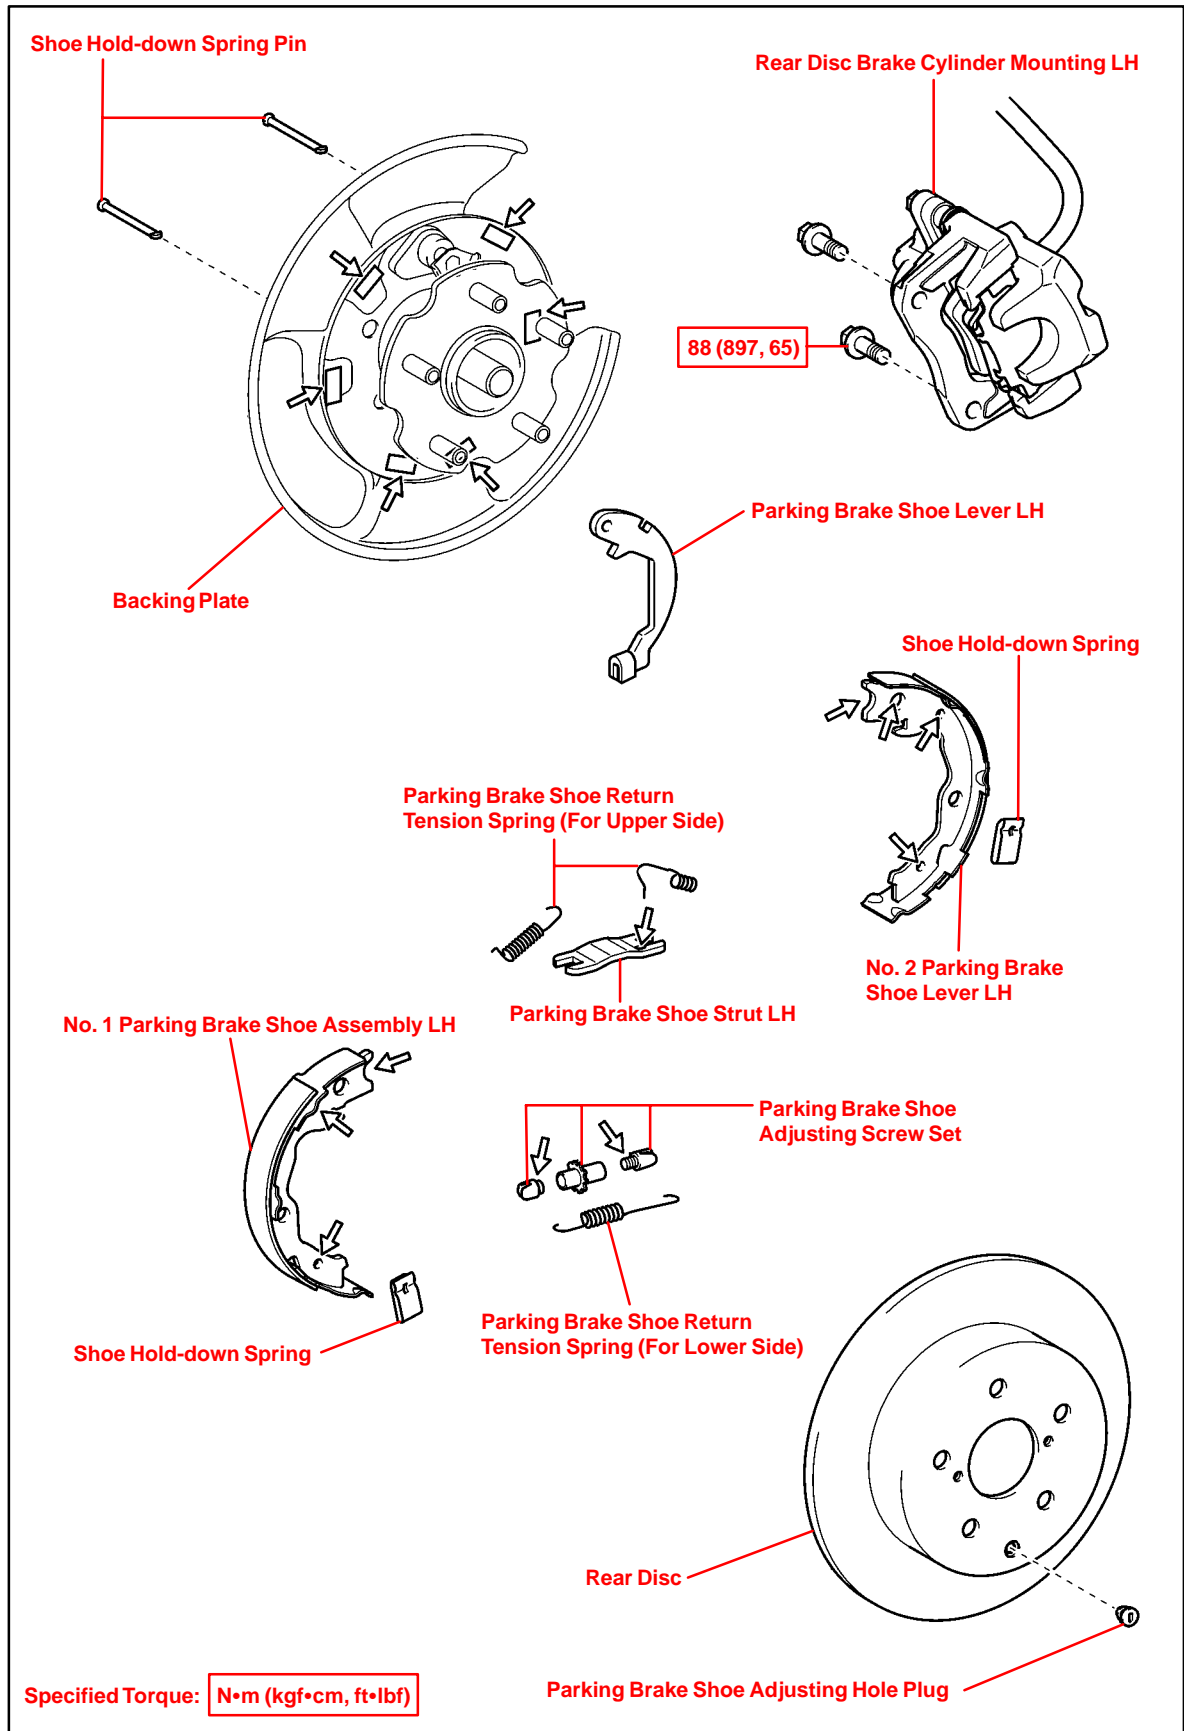
Components

Introduction Some customers may experience a click noise coming from the left rear brake area when utilizing the parking brake hand lever. Updated parking brake shoe lever service parts are available to improve the noise condition.

1. Operate the parking brake lever several times and listen for a click noise coming from the left rear brake area.
2. Remove and replace the left rear Parking Brake Shoe Lever (P/N: 46602–42040) by following the procedures in the Technical Information System (TIS):
